**CITY OF SANTA BARBARA
HISTORIC LANDMARKS COMMISSION**

**RESOLUTION RECOMMENDING THAT CITY COUNCIL
DESIGNATE AS A CITY LANDMARK
THE SAN MARCOS BUILDING
1129 STATE STREET
(PROPOSED DESIGNATION WOULD INCLUDE: 1119-1137 STATE STREET AND 9-15
WEST ANAPAMU STREET)
ASSESSOR PARCEL NO. 039-231-037**

**HISTORIC LANDMARKS COMMISSION
LANDMARK DESIGNATION
STAFF REPORT**

**THE SAN MARCOS BUILDING
1129 STATE STREET
SANTA BARBARA, CALIFORNIA
APN 039-231-037
JULY 15, 2015**

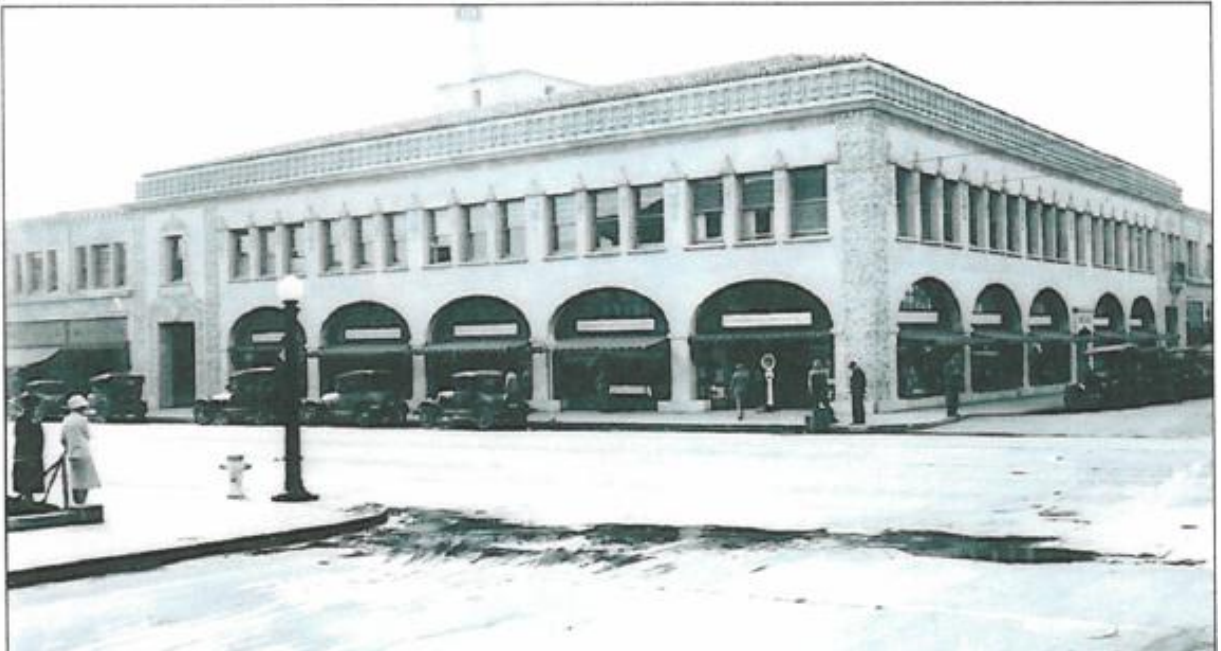
*Above: San Marcos Building after 1926 reconstruction.
Robert Easton Collection, Santa Barbara Public Library*

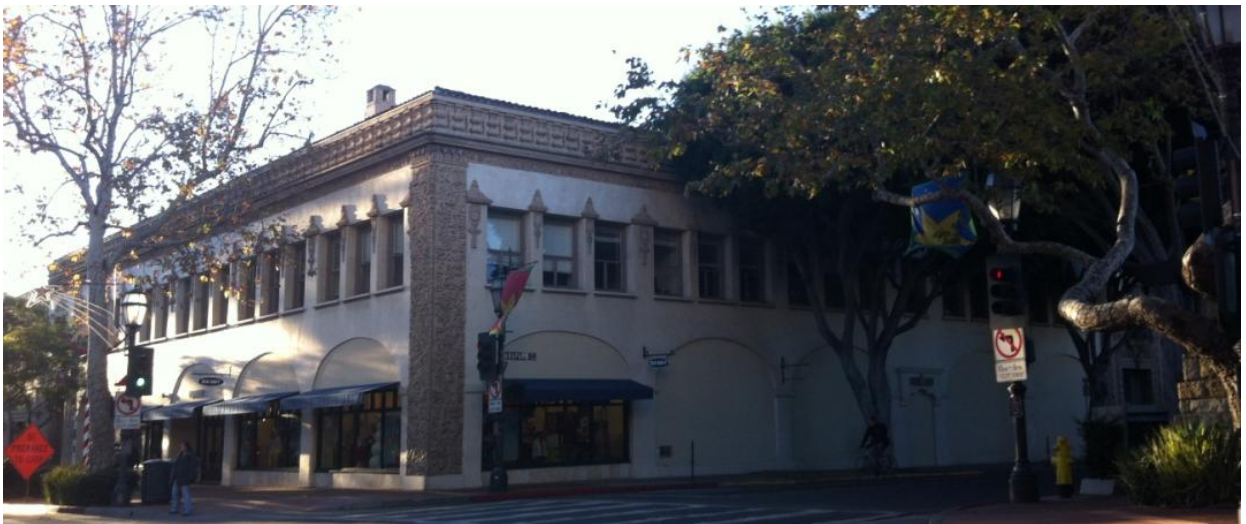
Above: San Marcos Building, December 2012.

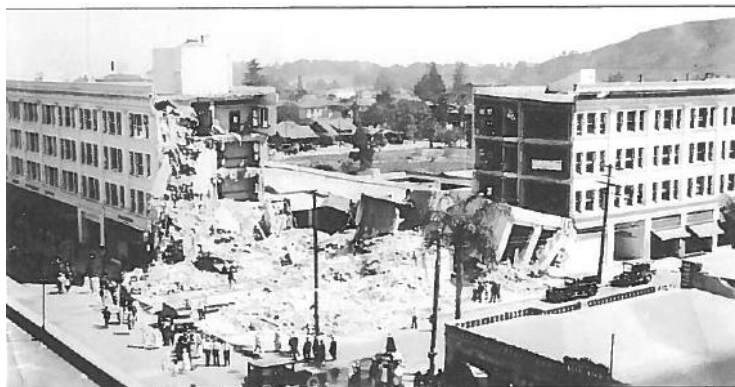
*Above: San Marcos Building after 1925 earthquake. The State Street and Anapamu Street elevations were reduced to two stories and the corner reconstructed in the Churrigueresque style in 1926.
Robert Easton Collection, Santa Barbara Public Library*

In 1913, architect J. Corbley Pool designed a rectangular-shaped commercial building for merchant banker John S. Hawley. In 1923, a four-story adjunct was added at the west side of the Anapamu Street façade to form an L-shape building. The 1925 earthquake razed the northeast corner of the building (see photo 3). The earthquake coincided with profound changes in the architectural expression in Santa Barbara, where the city could be unified through the Spanish Colonial Revival Style. Santa Barbara was looking for a visual image with which to link its Spanish past to future developments within the City. A Civic League of citizens hired the planner Charles Mulford Robinson to determine the City's assets and to offer plans for development. Robinson pointed to the City's Hispanic heritage as a focal point for a unifying architectural style. In 1926, noted architects Myron Hunt and H. C. Chambers incorporated the adopted standards of the Spanish Colonial Revival architecture into a design for the building reconstruction. They designed the corner section of the San Marcos Building to be reconstructed using extensive Spanish Churrigueresque cast concrete detailing, and arched paseos leading from State Street and Anapamu Street to an interior courtyard (See photos 1, 2 and 4). Part of the Hunt and Chambers design was a tower on top of the Churrigueresque building. The tower remains today in its original configuration.

The portions of the building that survived the earthquake were reduced to two-stories. The second floor triple sets of windows were left unaltered. The rectangular storefronts on Anapamu Street with glass tile transoms remained unchanged from their appearance before the earthquake. Although the San Marcos building was one unified structure, Hunt and Chambers created the illusion of three buildings fronting State Street by designing three separate and unique facades along State Street and the older portion on Anapamu. The older portions were differentiated from the 1926 construction because the roofline was slightly lower and Churrigueresque styling was absent (see photos 5 and 6).

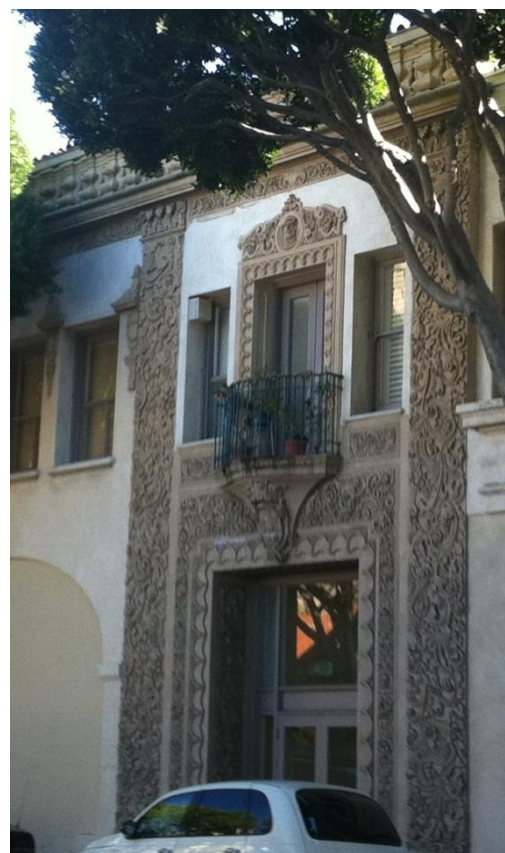
Above: East elevation of San Marcos building illustrating Churrigueresque detailing around door and window.

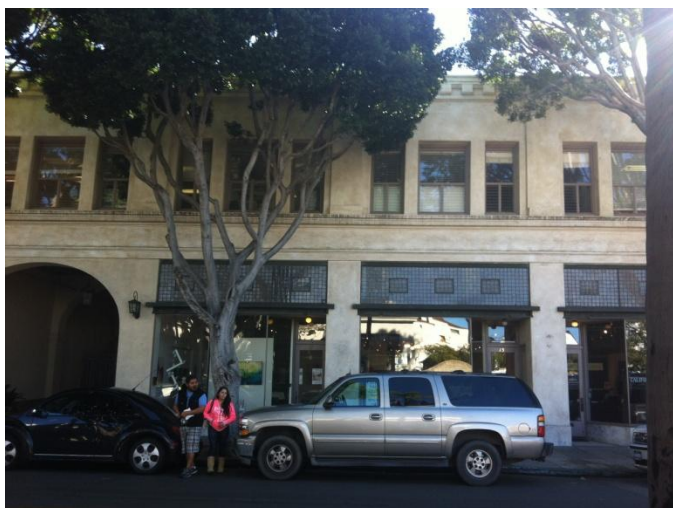
Above: Anapamu St. elevation of San Marcos building illustrating the 1923 section of the building reduced to 2 stories in 1926 with original storefront transoms. December, 2012.

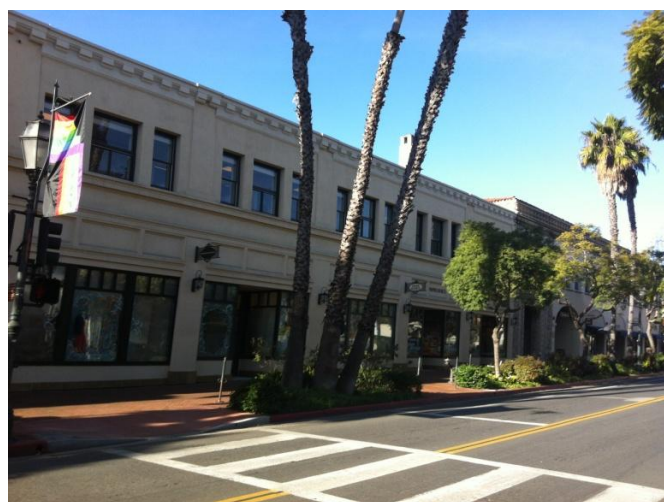
Above: State St. elevation of San Marcos building illustrating the 1923 section of the building reduced to 2 stories in 1926. December, 2012.

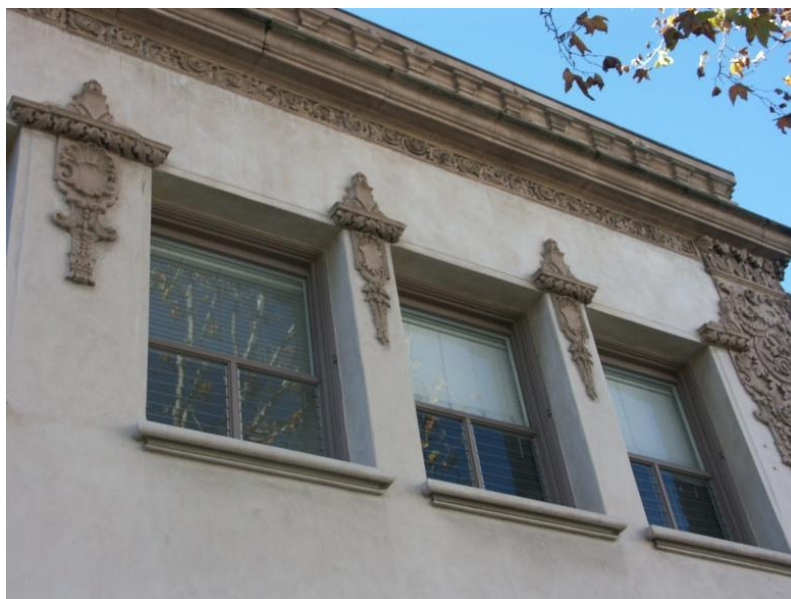
Above: Churrigueresque detailing on the San Marcos Building. December, 2012.

Churrigueresque architecture is from the Baroque style of Don Jose Churriguera (1650-1723) of Salamanca, Spain and his sons in late seventeenth century to early eighteenth century and later developed in Spanish Colonial architecture of Mexico. The style is characterized by elaborate decoration and picturesque assemblages as seen on

the San Marcos Building (see photo 6). Architect Bertram Goodhue designed substantial Spanish Colonial buildings at Balboa Park in San Diego using elaborate cast stone detailing that defined Churrigueresque style. The more elaborate style was not particularly popular in Santa Barbara where the simpler forms of the Spanish Colonial Revival style were

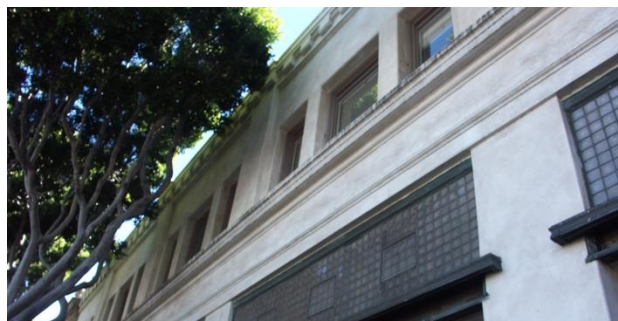
Above: The original transoms over the storefronts on Anapamu Street feature small detailed divided lights . December, 2012.

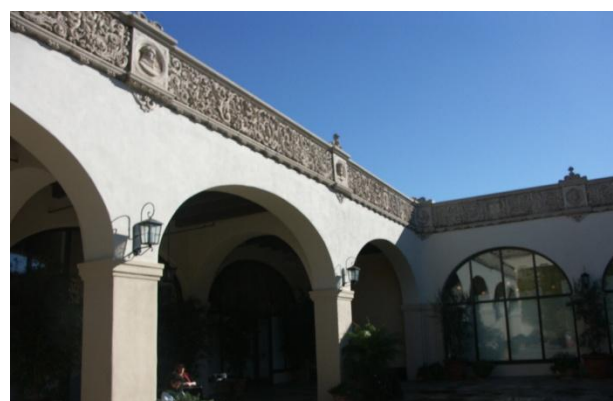
Above: View of the courtyard that demonstrates the ornate cast stone cornice and medallions. December, 2012.

5. **Interior courtyard:** There were modifications and additions done to the design of the interior courtyard space in 1949 by Woothworth's where the northeast corner of the courtyard was filled with an addition to the building. The courtyard originally had an arcade of arched openings on each elevation that have been filled with storefront glass, although the Churrigueresque cornice band remains.

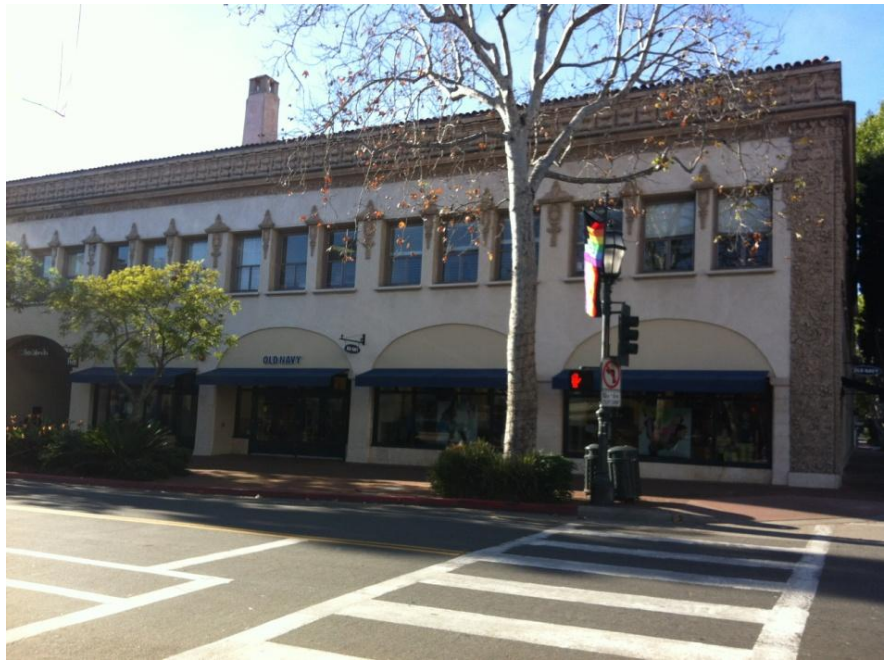
The building demonstrates excellent attention to architectural detailing. The building is a striking example of Churrigueresque architectural design elements as it displays a low-pitched, hipped roof clad with clay tiles surrounded by a wide intricately embroidered cast stone cornice, intricate, highly

embellished cast-stone corner pilasters and the original elaborate main entrances to the paseos, and details between the second story windows demonstrate outstanding attention to design, detail, materials and craftsmanship.
